TECHNICAL ADVISORY COMMITTEE #4 CAPITAL IMPROVEMENT AND INFRASTRUCTURE

Planning and Design for ADA Improvements Veterans Memorial Hall, Manual Arts Building, and Recreation Gymnasium County of Del Norte

Americans with Disabilities Act (ADA) Transition Plan Update Information Technology

Americans with Disabilities Act (ADA) Transition Plan Update Veterans Memorial Hall

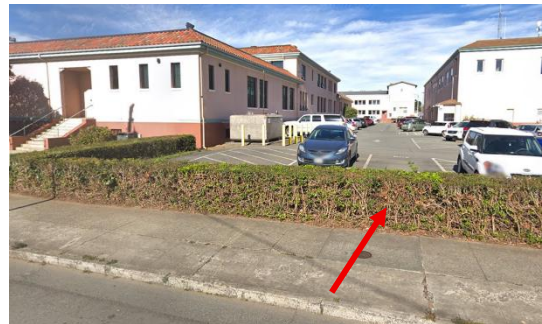
Pedestrians are not provided with an accessible route from the sidewalk to either of two entrance doors to this facility (see photo).

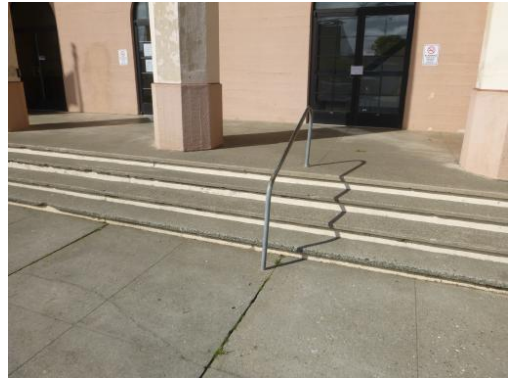
The segment of sidewalk between the parking lot and building entrance, and the plaza in front of the stairway appear to be in original condition with trip hazards and non-compliant cross slopes. The metal ramp installed at the stairway was identified with running slopes of over 11% where 8.3% is the maximum allowable slope under the ADA or CBC (see photo). It may be possible to reconfigure or lengthen the ramp by adding additional sections and constructing a new concrete landing in the grass planter closer to the corner to reduce the slope. The stairway leading to the entrance has only one handrail and it is too low for safe use by adults and lacks extension that help users to steady themselves while traveling up and down. Marking stairway treads, the surface we walk on, is a requirement under the ADA and CBC because it reduces trip and fall accidents for all users.

The most dangerous time for a person with a disability to use stairs is when they descend. If each tread nosing is marked with a contrasting color, it is less likely that pedestrians will trip and fall. The width and location where the contrasting color is placed is regulated closely under the CBC. In this location, the risers are painted white, which may be confusing to people with low vision or neurological disorders, or similar (see photo). While it is not prohibited, it is not recommended especially when contrasting color on treads is also provided, as required. The stairs treads were identified with damage and lack contrasting color, which is an important visual aid for all users, including those with vision disabilities.

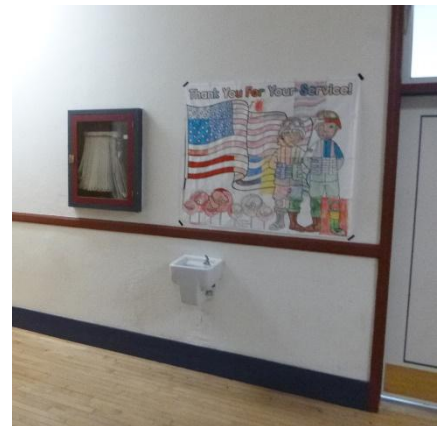
The main entrance to the facility leads into the lobby space that connects to the main hall, kitchen and dining room, the VFW Auxiliary Meeting Room, and a corridor that connects to the Veterans Services Offices, library, and canteen. In the main hall, a stage is provided with two stairways but no vertical access for wheelchair users. There is only one water fountain provided in the facility, and it appears to be original to the facility (see photo). The water fountain provided does not have adequate knee clearance, nor is it located in an alcove. No high fountain was provided for individuals with bending or stooping injuries.

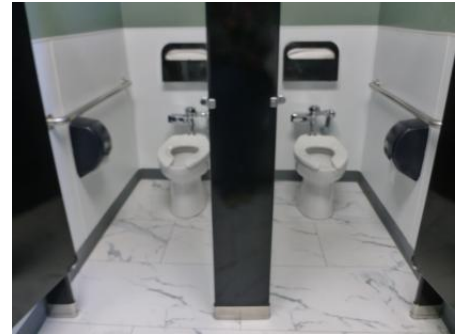
The accessible restrooms are located in the corridor that connects the main hall, VFW Auxiliary, and the dining room. The corridor leading to the toilet rooms is 42-3/4" wide and lacks clear width for corridors serving an occupancy greater than 10, which also reduces

access at entrance doors to the toilet rooms. The multi-accommodation toilet rooms appeared to have been altered since the enforcement date of the ADA, yet while the finishes, fixtures and stall compartment appeared to have been replaced, entrance doors and vestibule doors, accessories, dispensers, mirrors, urinals and toilets were not accessible. In the women's toilet room, two narrow stalls were constructed with side grab bars (see photo), but the stalls are not wide enough to allow a wheelchair to enter, and the stalls are not long enough to allow a wheelchair to enter and close the door.
